**TRANSPORTATION SCIENCES CENTER
ACCIDENT RESEARCH GROUP**

**CALSPAN ON-SITE AIR BAG DEPLOYMENT INVESTIGATION
CALSPAN CASE NO. 95-21
VEHICLE: 1995 DODGE CARAVAN
LOCATION: MARYLAND
CRASH DATE: [REDACTED] 1995**

This on-site investigation focused on a child fatality that resulted from the deployment of the passenger side air bag in a 1995 Dodge Caravan. The 7 year old female child occupant was the right front passenger in the Caravan that was occupied by the 43 year old male driver and two additional child occupants seated in the second seat of the seven passenger vehicle configuration. On an approach to a four-leg intersection, the driver was momentarily distracted and failed to detect a red signal phase. He braked, however, the full frontal area of the Caravan impacted the left side area of a 1992 Chevrolet Lumina APV which resulted in deployment of the Dodge's supplemental driver and passenger side air bags. The right front child occupant was out of position in a forward direction as a result of the pre-crash braking force and within a close proximity to the passenger side air bag module assembly. The deploying air bag contacted the underside of her chin, face, anterior neck, an

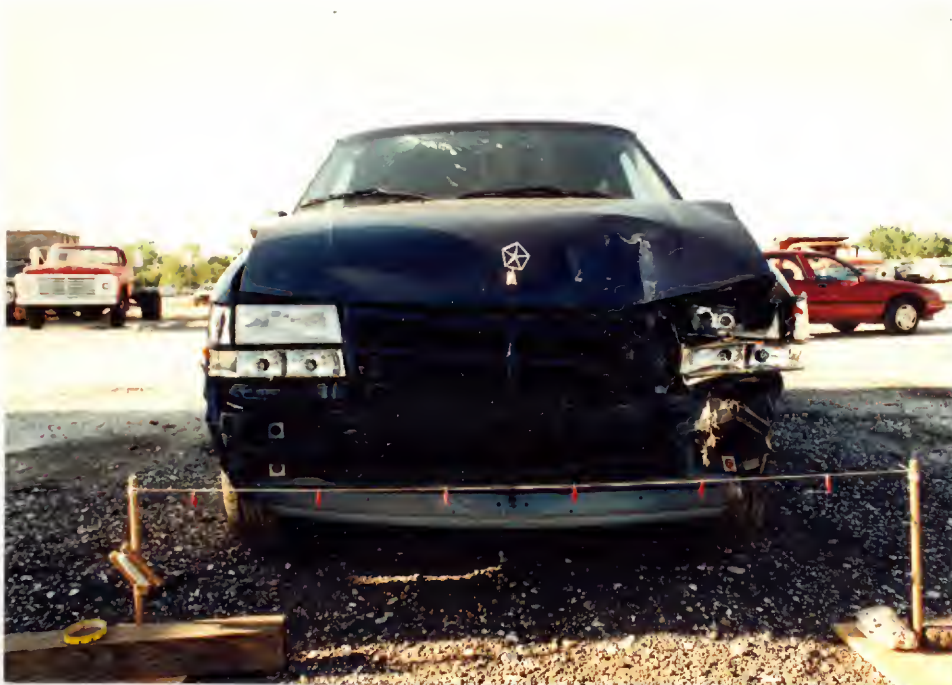
| <u>Air Bag Vehicle</u> | <u>Vehicle #2</u> |
|---|---|
| The 1995 Dodge Caravan sustained moderate damage that was distributed across the entire frontal plane of the vehicle. The front-to-side impact sequence crushed the front bumper structure of the Caravan and separated the bumper fascia from the reinforcement bar. Direct contact damage, which consisted of abrasions, began at the right front corner of the bumper fascia, 77.5 cm (30.5") right of center, and extended 154.31 cm (60.75") to the left corner area. The vertical height of the direct contact damage extended onto the hood face and leading edges of the front fenders. | The 1992 Chevrolet Lumina APV sustained moderate left side damage from its impact sequence with the Dodge Caravan. The composite exterior body panels of the Lumina APV compressed as a result of the impact and rebounded to approximately the original positions. The steel substructure of the left B-pillar and sill areas retained the crush pattern from the engagement. Direct contact damage consisted of abrasions and paint transfers which began 116.2 cm (45.75") forward of the left rear axle position and extended 160.0 cm (63.0") forward to the left front wheel. |

11. Frontal damage to the 1995 Dodge Caravan.

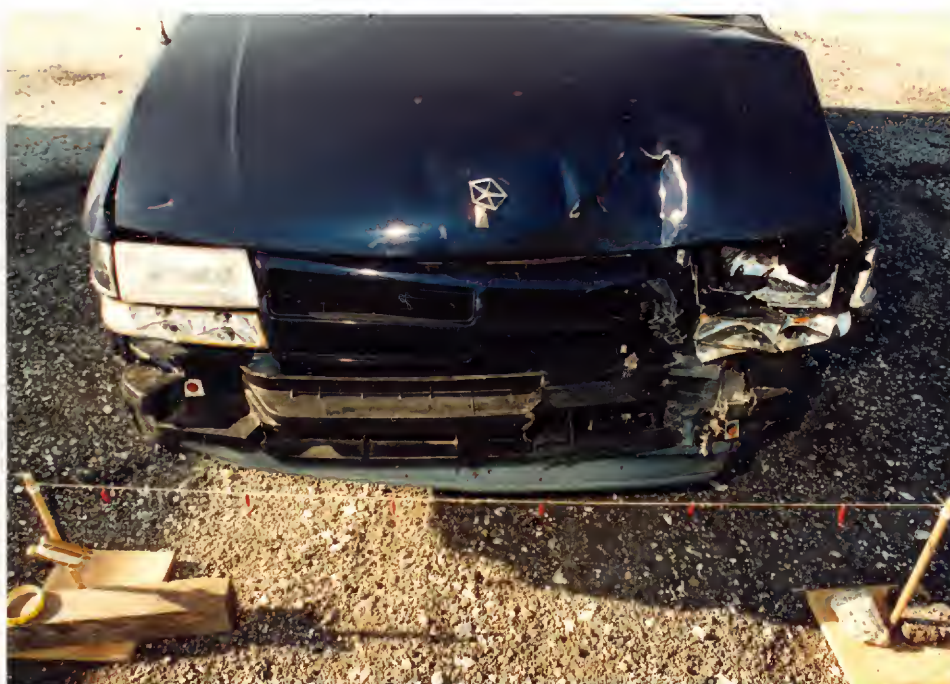
12. Close-up view of the frontal impact damage.

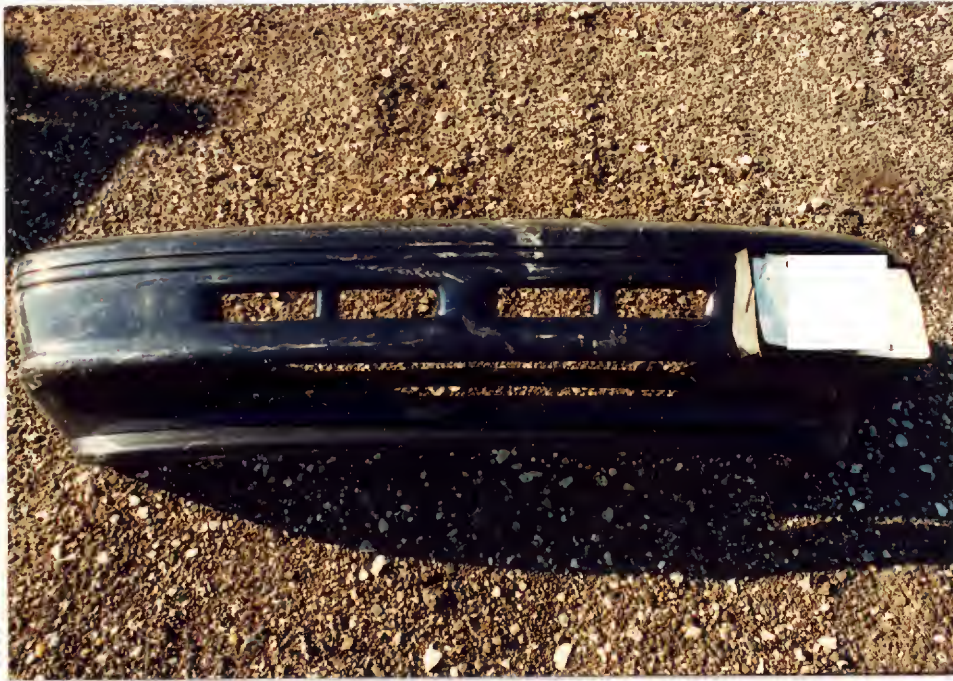
13. Direct contact damage across the full width of the bumper facia (separated).

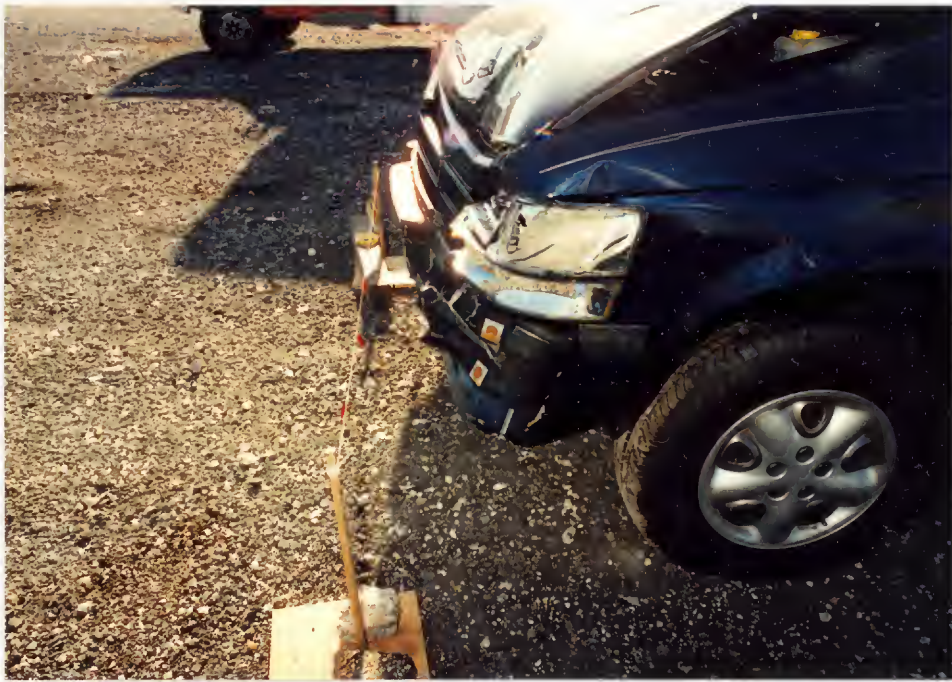
| | <u>Air Bag Vehicle</u> | <u>Vehicle #2</u> |
|---|---|--|
| Exterior (Cont'd.) | <p>Maximum crush was 26.4 cm (10.4") located at the left front corner of the fiberglass-type bumper reinforcement bar. Crush values at bumper reinforcement bar level were as follows: C₁=26.4 cm (10.4"), C₂=23.1 cm (9.1"), C₃=8.9 cm (3.5"), C₄=6.6 cm (2.6"), C₅=4.8 cm (1.9"), C₆=5.7 cm (2.25").</p> <p>Components damaged by the crash involved the front bumper facia and reinforcement bar, grille, left headlamp assembly, both parking light and turn signal assemblies, hood, and both front fenders. Rearward displacement of the frontal structure did not result in reduction of the wheelbases.</p> | <p>Maximum crush was 7.6 cm (3.0") located at the base of the left B-pillar. The residual crush profile was located at the sill of the vehicle and extended from the left A-pillar to the B-pillar. Crush values at this level were as follows: C₁=7.6 cm (3.0"), C₂=6.6 cm (2.6"), C₃=7.0 cm (2.75"), C₄=5.1 cm (2.0"), C₅=3.6 cm (1.4"), C₆=0 cm (0.0").</p> <p>The displacement of the left B-pillar resulted in the release of the left door latch from the strike post. In addition, the left wheel contact resulted in a fracture of the right tie rod.</p> <p>Damaged components included the left front wheel, right tie rod, left front fender, left door panel, left sill, left B-pillar, and the left rear quarter panel.</p> |

15. & 16. Profiles views of maximum crush at the left front bumper corner.

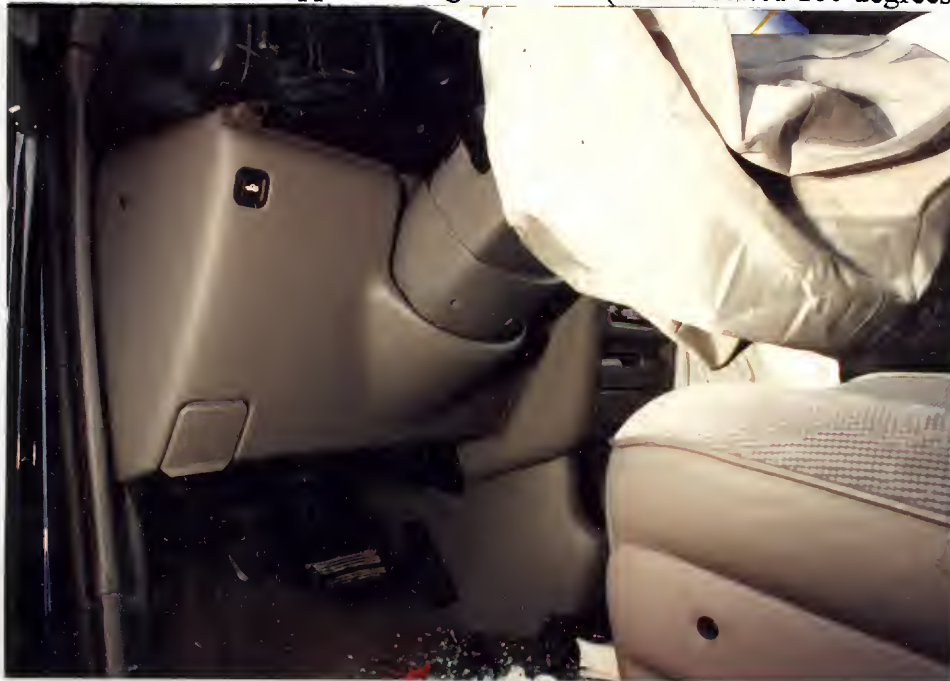
The driver's left knee probably contacted the left side of the plastic knee bolster. There was no evidence of contact to the exterior surface of the bolster, however, upon removal of the bolster to inspect the energy absorbing steering column, the lower left outboard mounting bracket of the bolster was fractured at the screw position. This damage could have resulted from knee loading or during the assembly process of the vehicle.

30. Driver's side knee bolster and exposed steering column assembly.

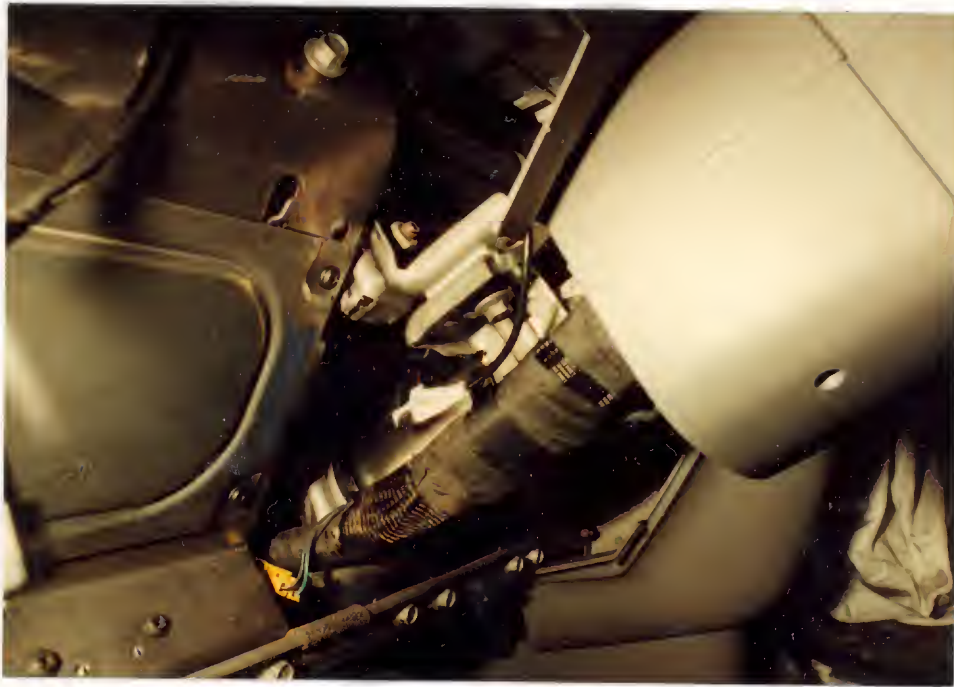
31. Energy absorbing steering column and left shear capsule (no compression).

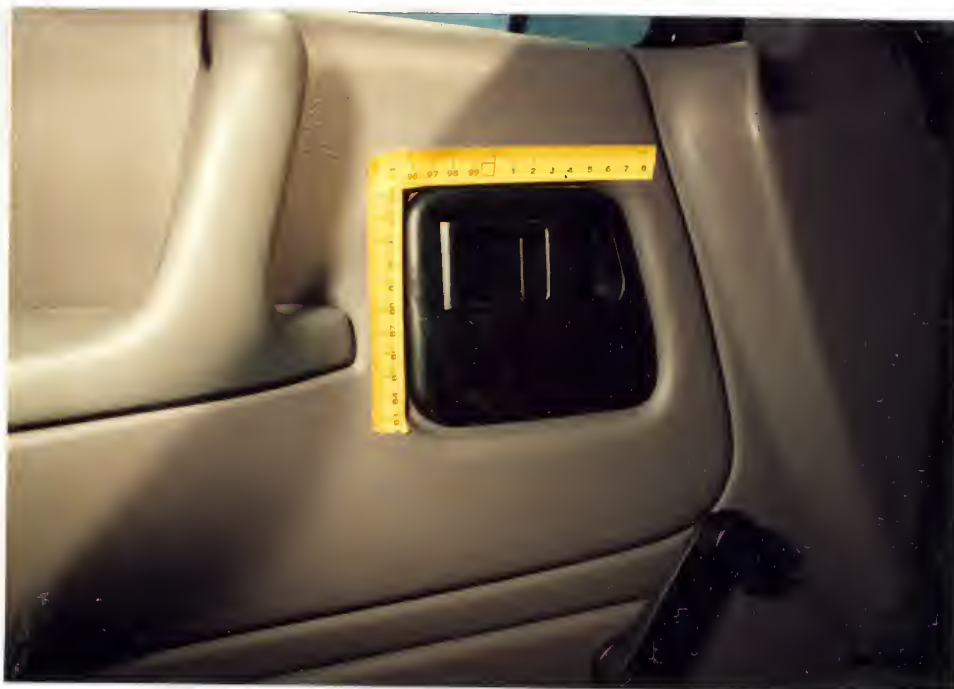
the air bag deployment, however, the inflating air bag contacted the anterior aspects of the driver's forearms which displaced his left hand from the steering wheel rim. The hand/wrist area contacted and scuffed the left door release lever plastic trim panel located at the upper forward quadrant of the door panel. The driver's left knee probably impacted the left side of the plastic knee bolster as he responded to the frontal impact force. Although no direct loading evidence was visible to the exterior surface of the bolster, the lower left mounting bracket was fractured at the head of the attachment screw.

36. Probable driver left hand contact (scuff/smudge/possible tissue) to the door release lever and trim panel.

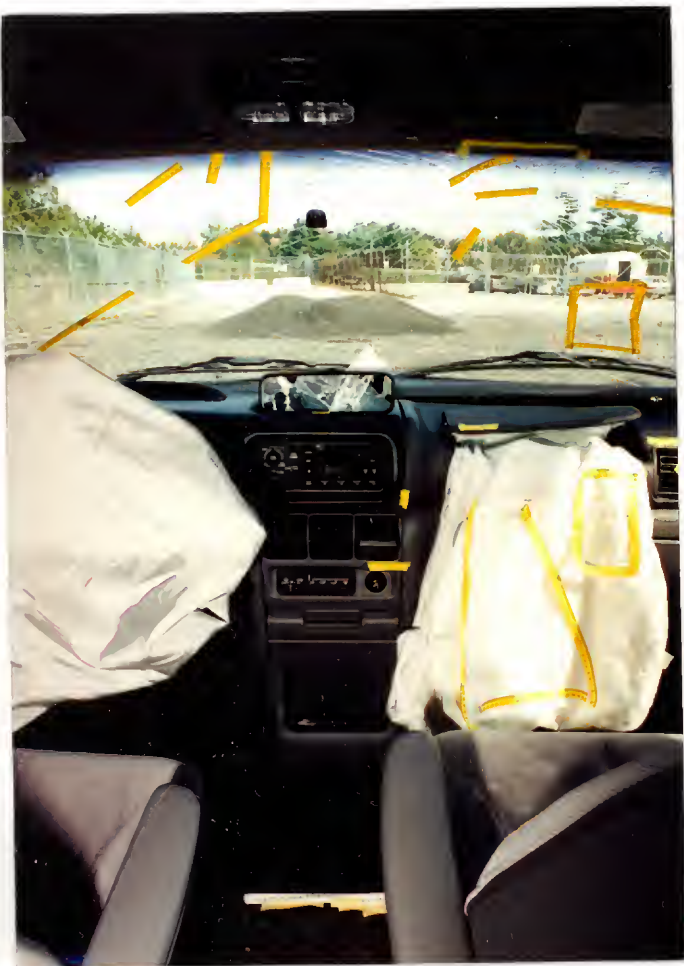
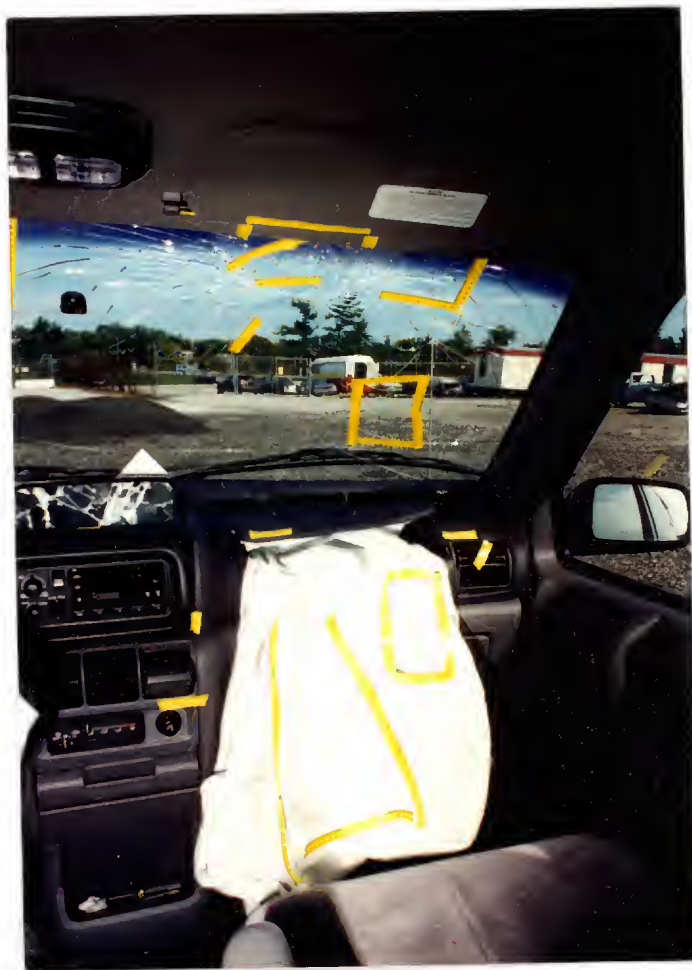
37. & 38. Overall views of the frontal interior surfaces, deployed air bags, and contact points.

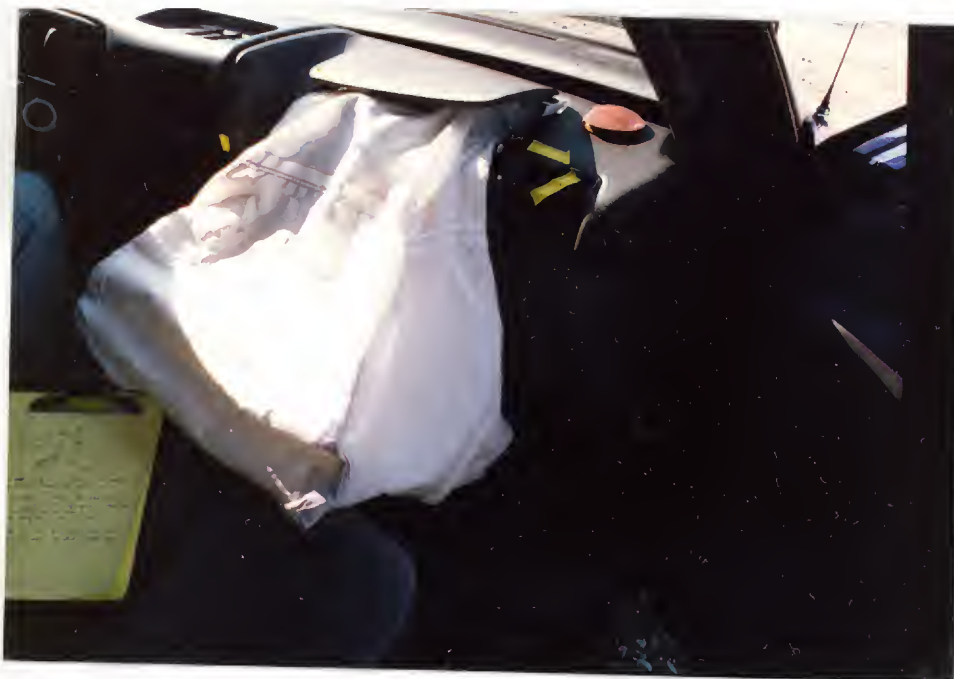
41. Top and right side view of the passenger side air bag.

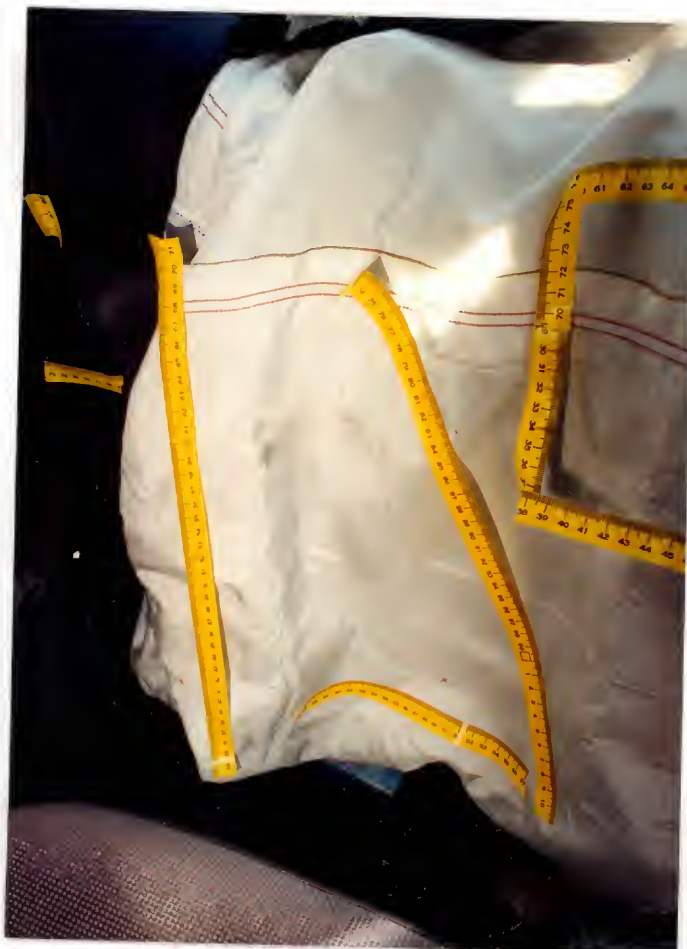
42. Longitudinally orientated gray vinyl transfers on left side of the passenger air bag.

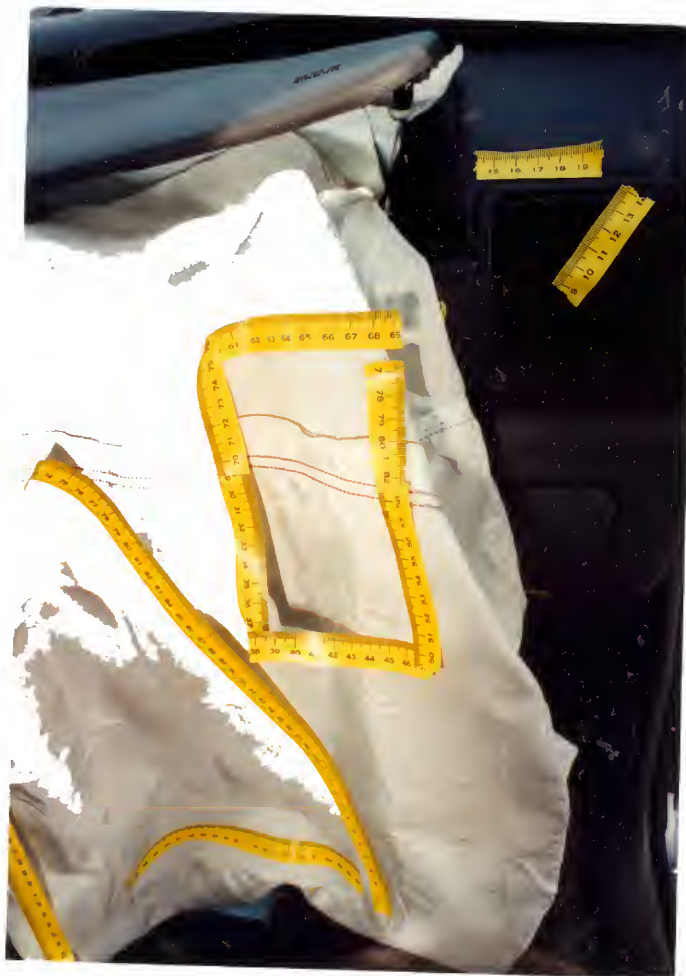
Passenger side air bag deployment against the child occupant's facial and neck areas resulted in numerous areas of tissue transfers. Located at the upper right quadrant of the air bag was an area of scattered tissue fragments which occupied an area of 3.2 x 4.45 cm (1.25 x 1.75"). These transfers are documented in Photograph Nos. 43 and 44. Additional tissue transfers were noted to the upper right side surface of the bag. These areas consisted of heavy transfers embedded into the fabric of the bag. The first tissue transfer to the side of the bag was located 12.7-20.3 cm (5.0-8.0") below a triangular blue stitch line and 7.0-10.8 cm (2.75-4.25") right of the apex of the stitch pattern. The second transfer extended 15.9-21.6 cm (6.25-8.5") right of the blue stitch line apex and continued from the end of the stitch line to a point located 7.6 cm (3.0") below the stitch line (refer to Photograph Nos. 45-48). An additional area of tissue was noted to the lower right quadrant of the windshield. This tissue involved fragments that were expelled from the occupants neck area as the bag expanded against the soft tissue.

43. Tissue transfer on right side area of the passenger side air bag.

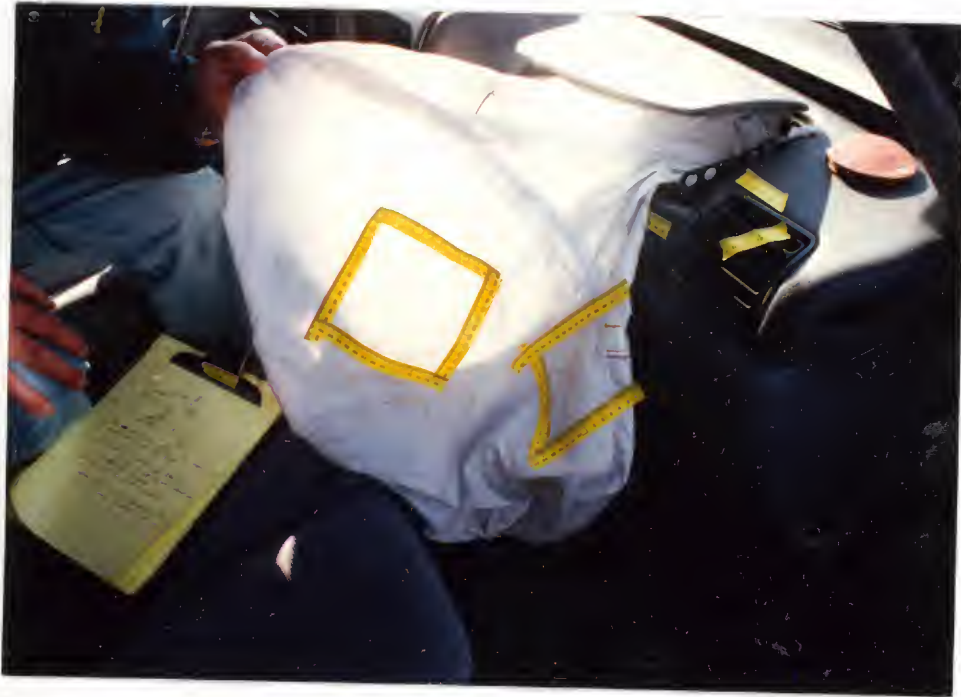
45. Additional tissue transfers on the right side panel of the passenger side air bag.

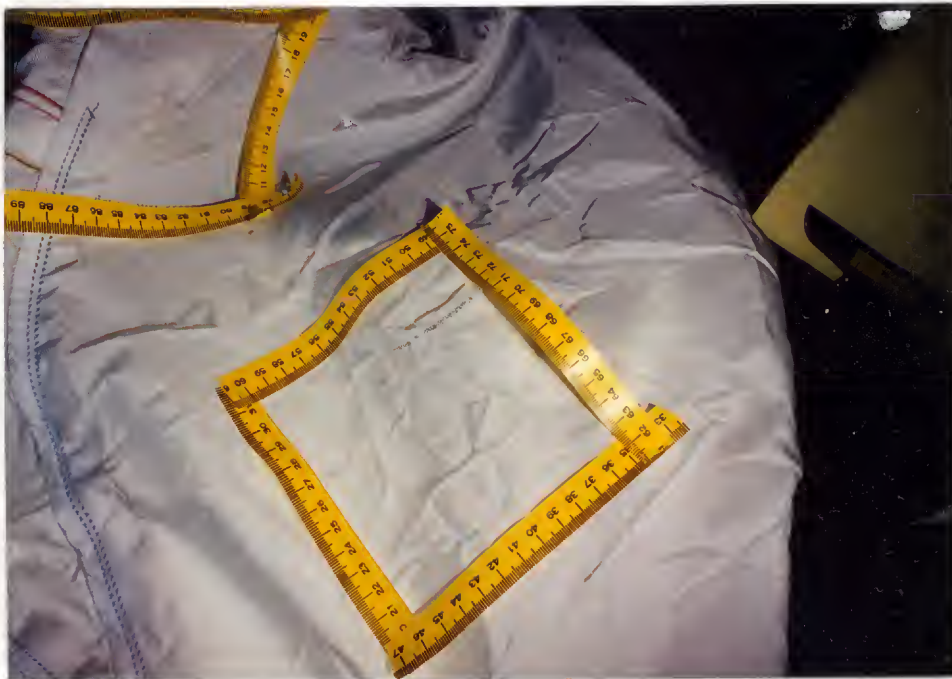
46. Close-up views of the above tissue transfers.

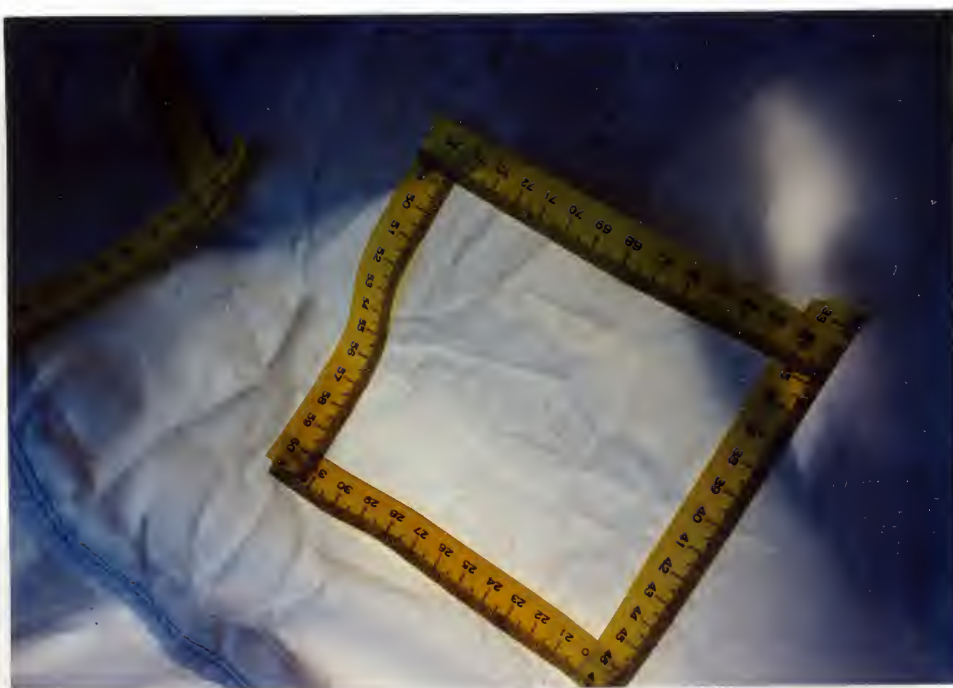
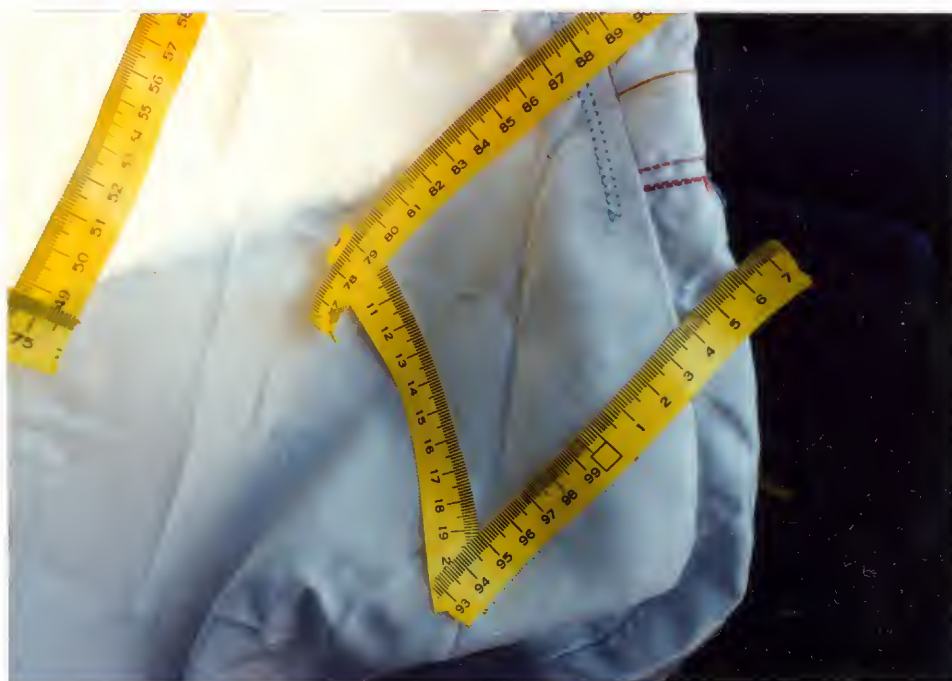
47. & 48. Additional close-up views of the right side tissue transfers.

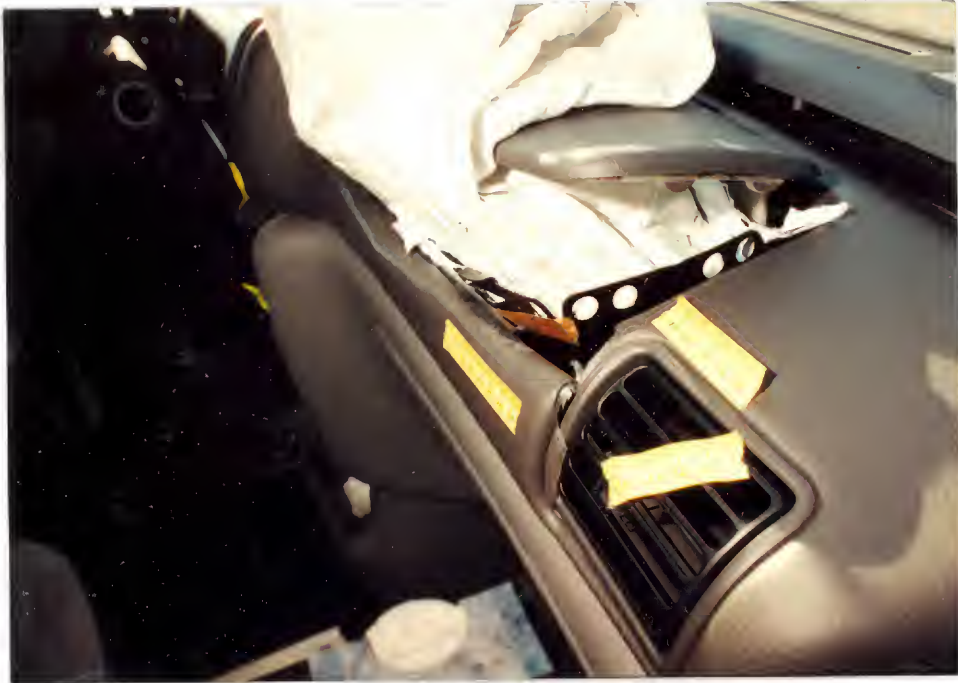
The bag expanded against the stamped steel air bag mounting bracket. The sides of the bracket were bowed outward approximately 3.2 mm (0.125") while the lower flange of the bracket was bowed 2.5 cm (1.0"). The outward bowing of the lower flange deflected the padded mid instrument panel 1.3 cm (0.5") downward at the mid point of the module assembly. An air bag fabric transfer was noted to the deformed padded mid panel (17.5-19.5") left of center and 69.9 cm (27.5") above the floor pan. The bowing of the module assembly, in combination with the opening of the top hinged cover flap and air bag expansion, resulted in a tear of the mid/upper instrument panel juncture at the narrow point adjacent to the right vent louver (refer to Photograph No. 51). A patterned air bag fabric transfer was noted to the left side of the right vent louver. The transfer measured 3.8 cm (1.5") vertically and 4.4 cm (1.75") horizontally across the upper left corner of the vent assembly.

49. Outward bowing of the lower and side surfaces of the passenger side air bag module mounting flange.

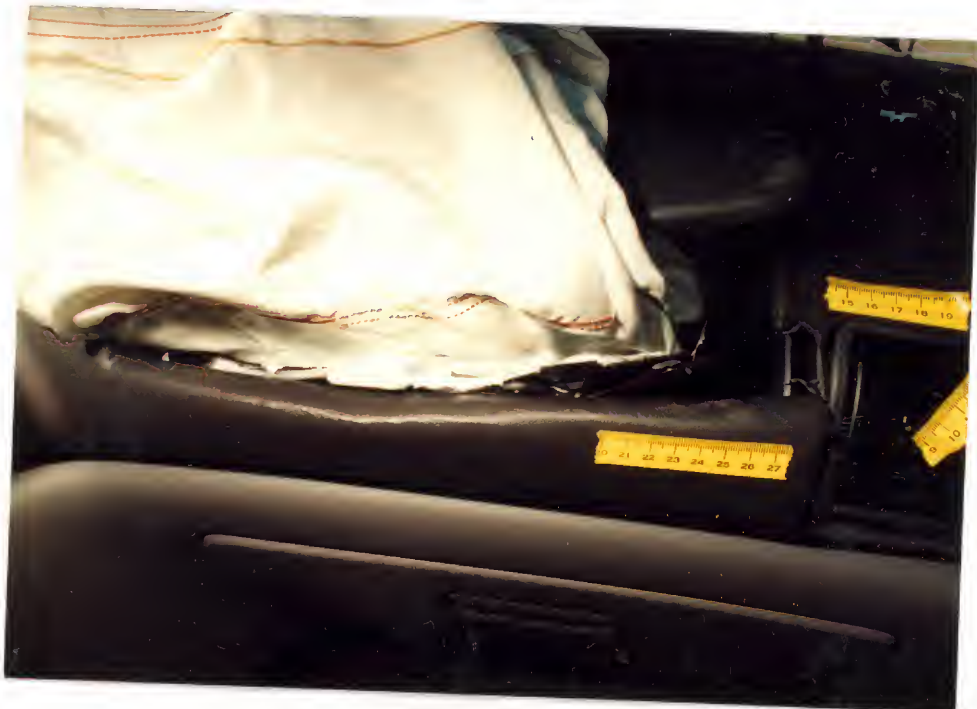
50. Lower flange bowed outward 2.5 cm (1.0") into mid instrument panel.

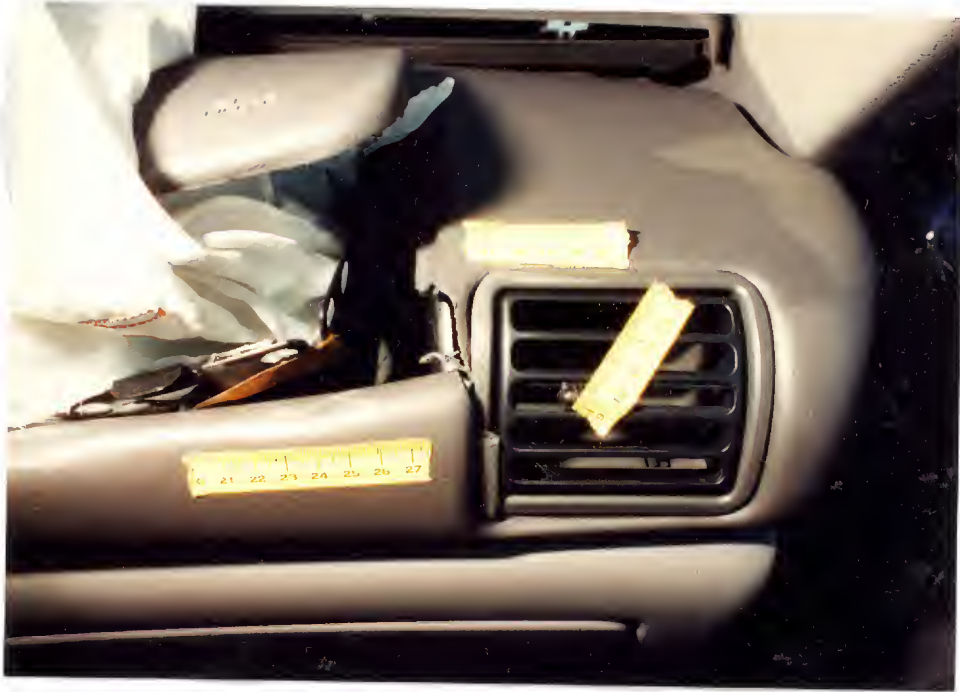
51. Air bag fabric transfers on deformed mid panel and right vent louver.

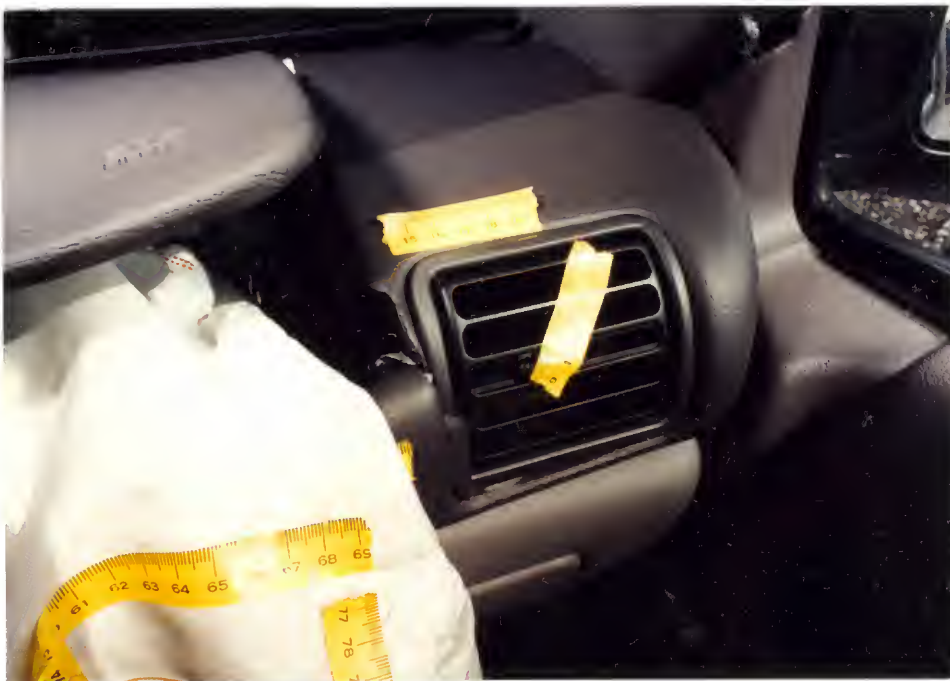
52. Close-up view of the air bag transfers on the right vent louver.

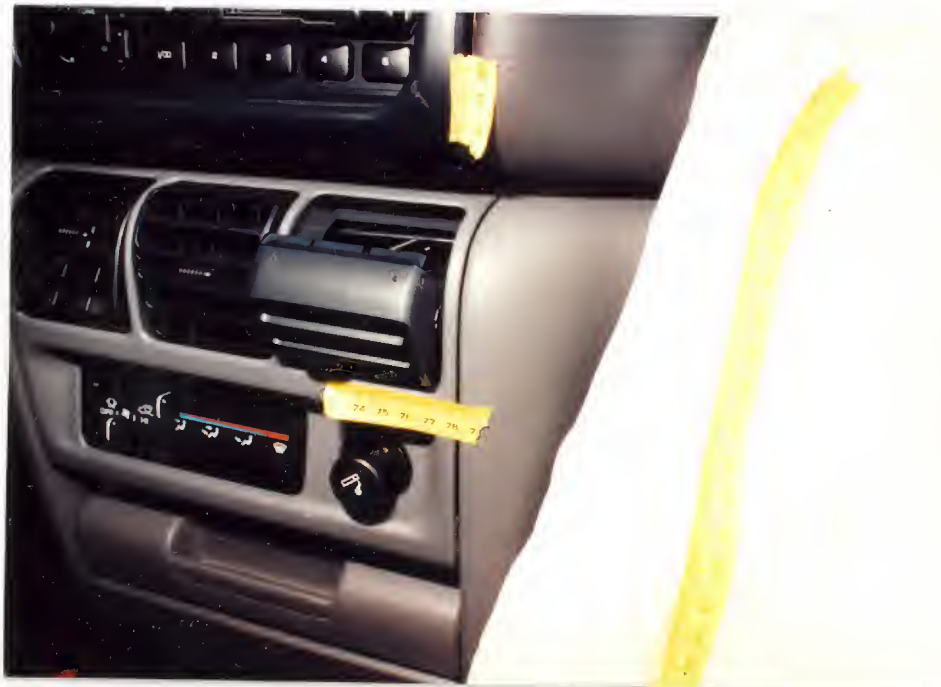
The center mid aspect of the instrument panel contained a series of three vent louvers located between the radio and the ventilation controls. The plastic right vent louver was fractured, but remained within its housing. A scuff mark was noted to the right side of the louver 11.2 cm (4.4") right of center and 21.0-22.2 cm (8.25-8.75") below the upper panel. Located directly above the fractured louver was a tissue transfer with a hair fiber within the transfer. A scuff mark surrounded the transfer which was 10.2 cm (4.0") right of center and 13.0 cm (5.1") below the upper panel. This transfer probably resulted from a hand contact and was within the area of the radio, however, there was no reported hand injuries to either the driver or the child right front passenger.

54. Fracture of the right mid mounted vent louver with tissue transfer located above.

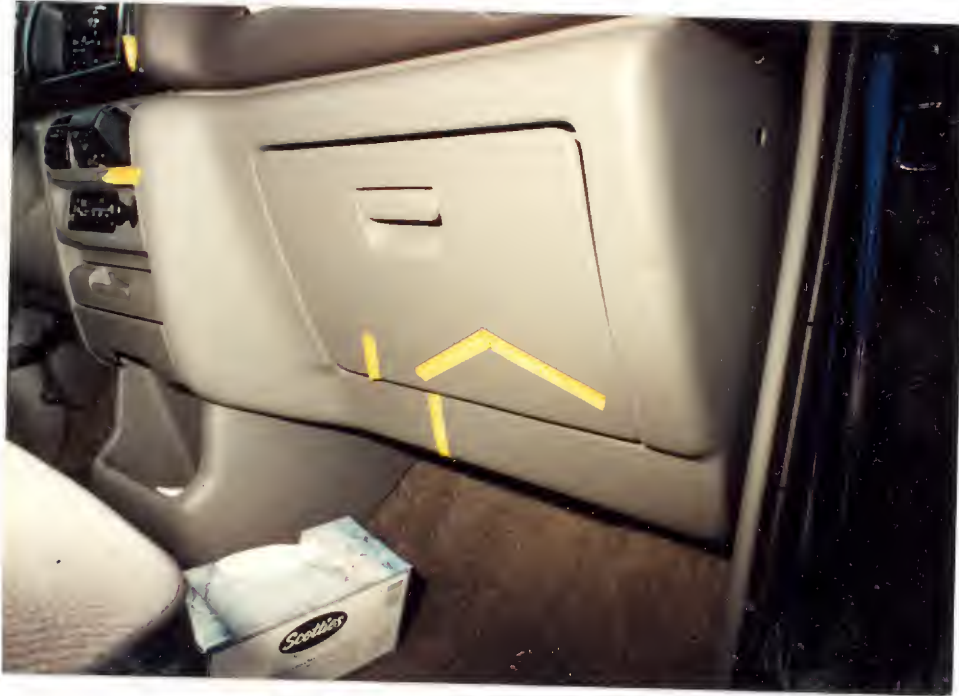
5. Possible foot scuff marks from the right front passenger on the glove box door.

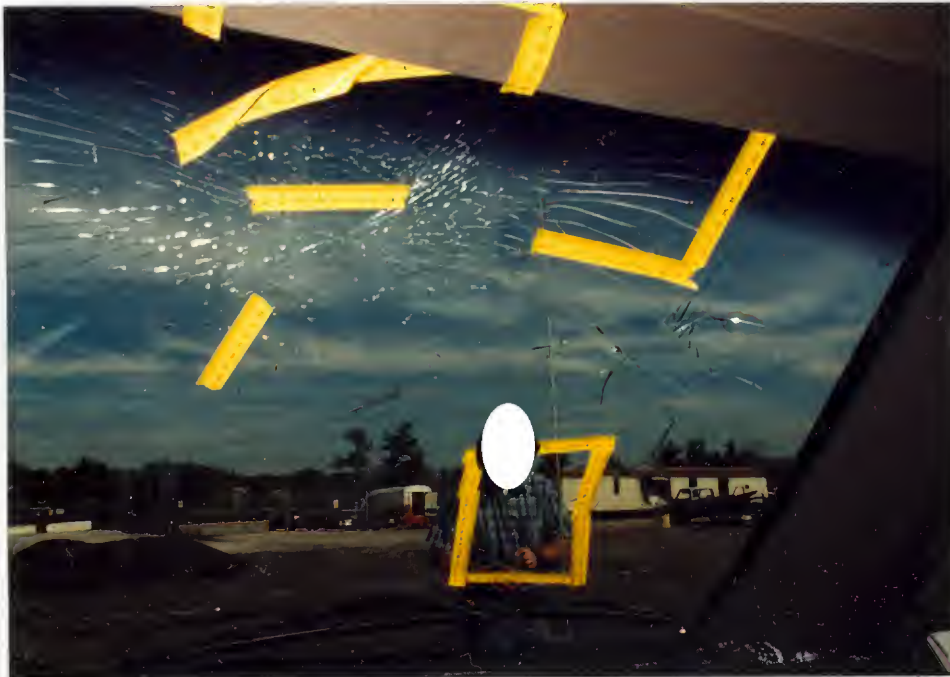
In addition to the fabric transfers on the windshield, a star-like crack occurred to the laminated glazing, located 27.9 cm (11.0") right of center and 6.4 cm (2.5") below the header. There was no contact evidence surrounding the impact point to the windshield, therefore the source of the crack was unknown. The possible sources include occupant contact; either head or hand contact from the right front passenger, or a fracture that resulted from air bag contact.

56. Crack and air bag contact to the laminated windshield.

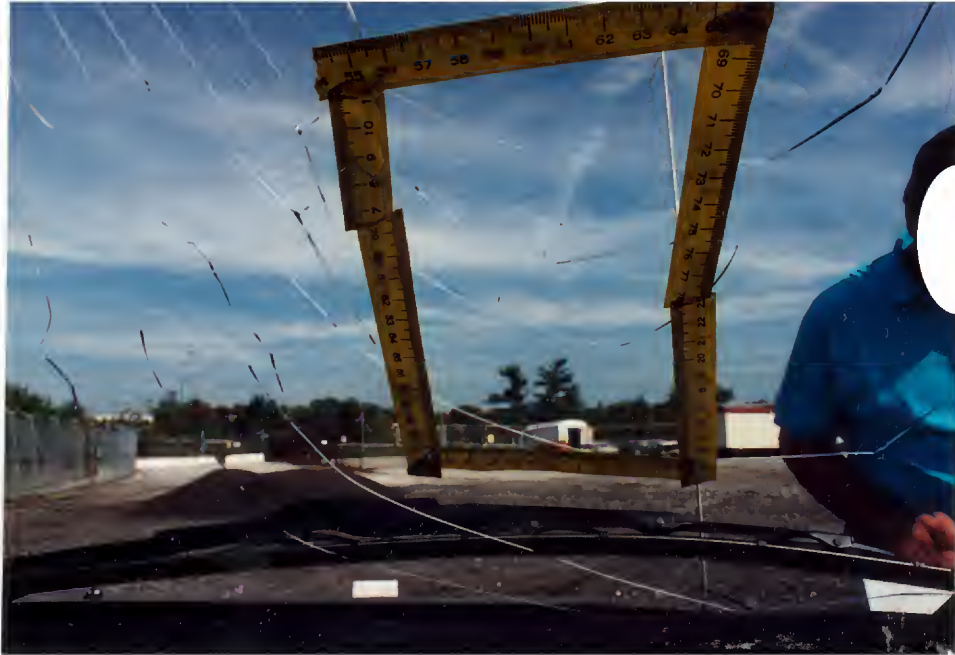
57. Probable tissue transfer on the lower right quadrant of the windshield.

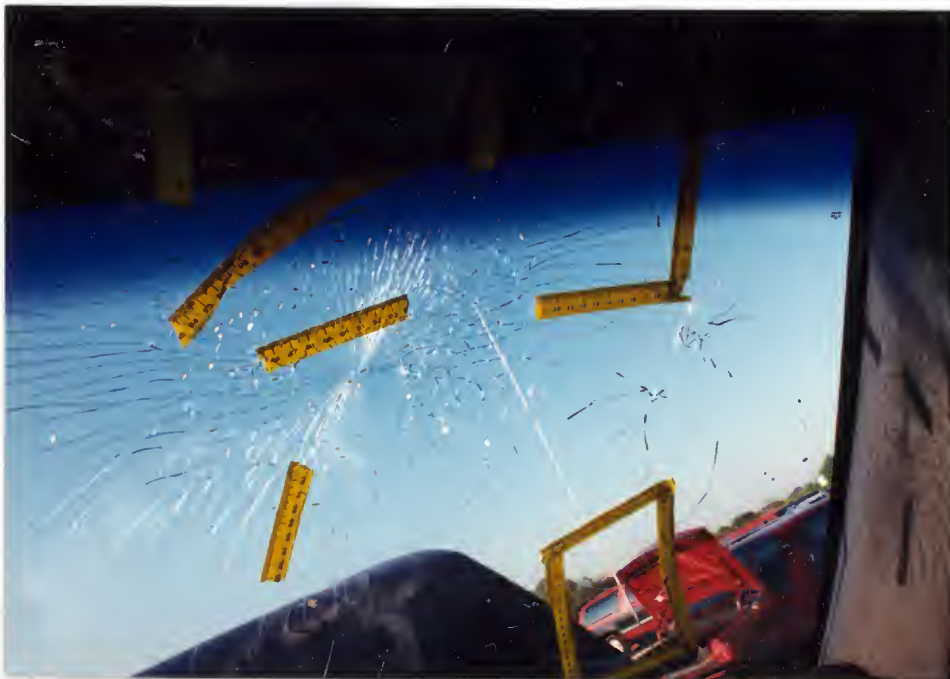
58. Air bag fabric transfer across the top of the windshield adjacent to the header.

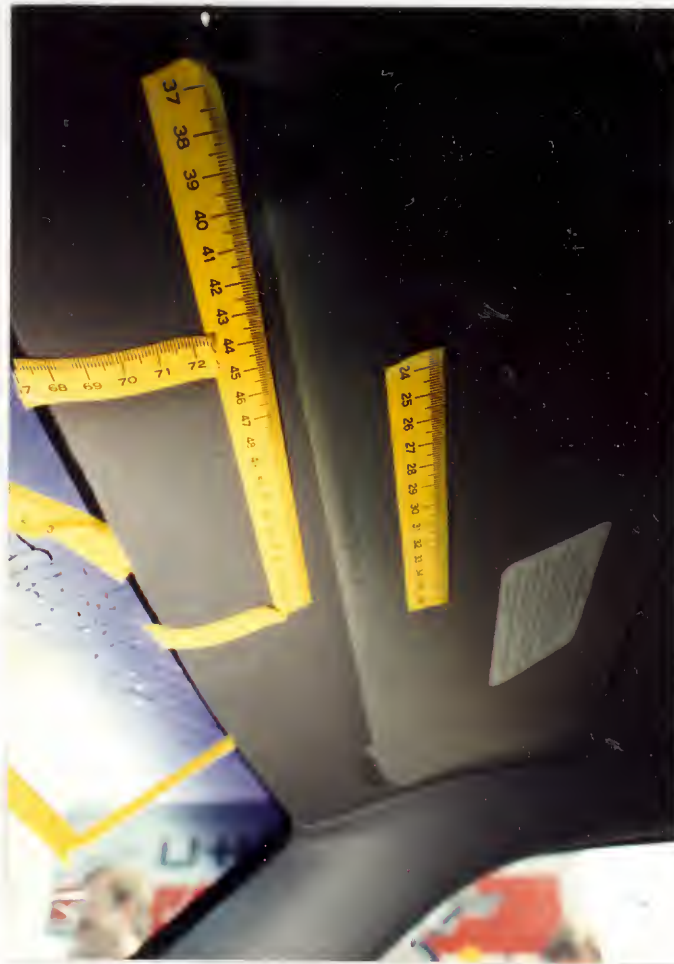
59. Abraded sunvisor and headliner from air bag contact.

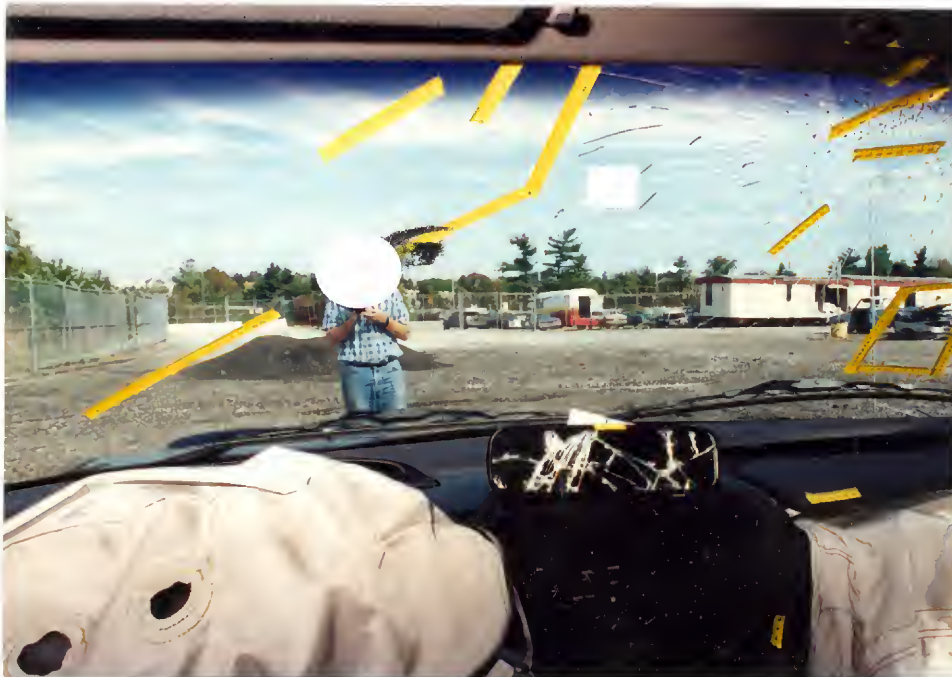
The left side area of the expanding passenger side air bag contacted the interior mounted rear view mirror as the right front occupant altered the deployment trajectory of the bag. The bag contact produced a fabric transfer to the right side of the mirror and displaced the mirror to the left, separating it from the windshield mount. Although no damage occurred to the plastic frame of the mirror, the contact cracked the full width of the mirror glass. The separated mirror was displaced across the left side of the windshield before coming to rest on the upper instrument panel at the base of the left A-pillar.

60. Fractured and separated rear view mirror from air bag contact.

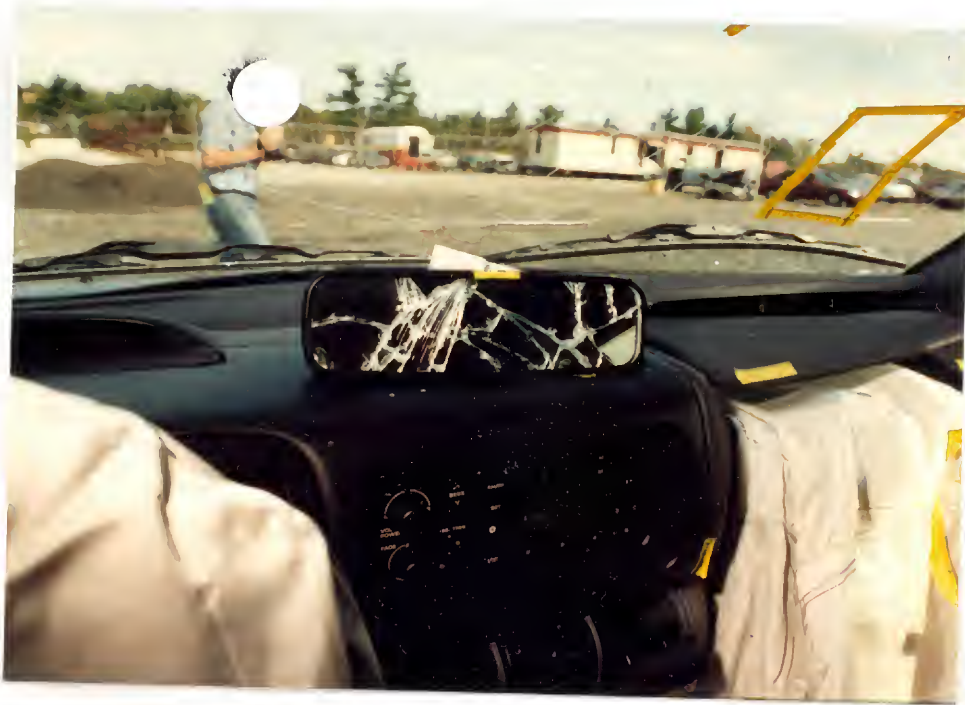
61. Close-up view of the cracked mirror.

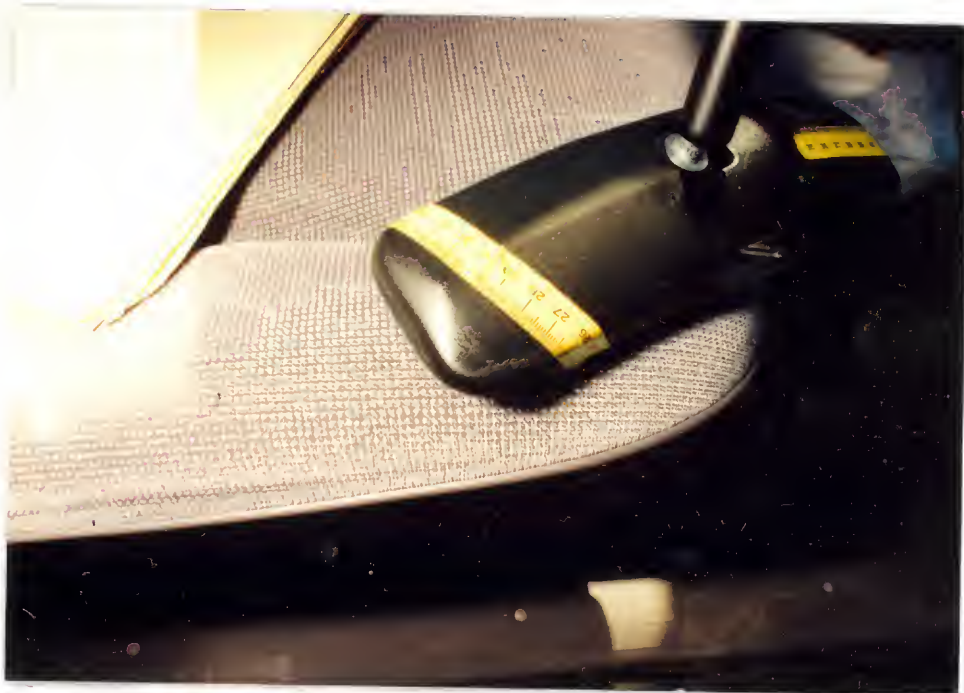
62. Air bag fabric transfer to the right side of the rear view mirror.

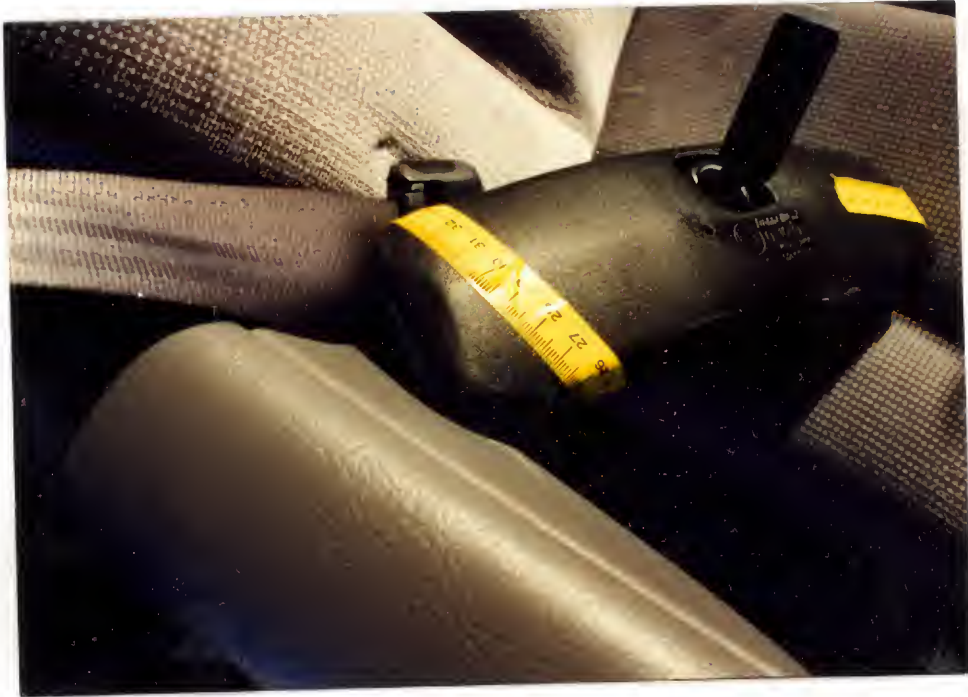
63. Close-up view of the fabric transfer.
